DSWA-TR-98-56

Research Program Tests for the U.S. Defense Special Weapons Agency (DSWA) for Breaching of Concrete Panels Set Against a Sandstone Rock Wall

May 2006

Prepared by:
New Mexico Institute of Mining
& Technology
Attn: EMRTC
801 Leroy Place
Socorro, NM 87801

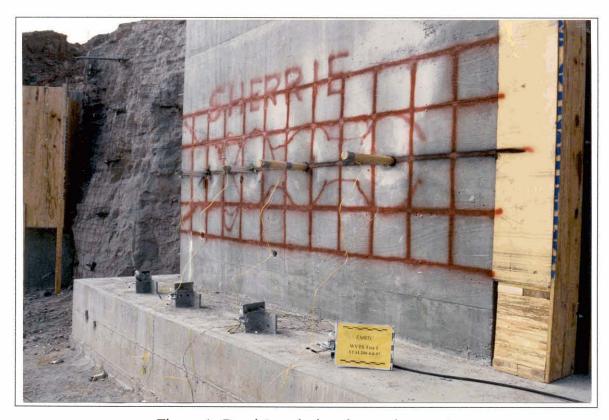
Figure 4. Panel 1 explosive charge placement.

The panel was drilled from the front face with four equally spaced 2-inch holes four feet above the bottom of the panel (Figures 3,4, and A). The explosive charges, composition C4 high explosives, were packed into thin wall acetate plastic tubing. Each charge was 2800 g with a loading density of 1.57 g/cc and was loaded into each hole in two pieces with a piece of PETN sheet explosive (C6 Detasheet) at the interface between the two pieces. A wooden dowel was used to stem each hole. A Nonel detonator was used to initiate each charge. A four-channel fire control system was used to initiate the Nonel detonators. Polyurethane foam was used on the side-wall of the panel closest to the last hole to be initiated in order to minimize the spall damage to the side of the panel. The front face and sides of the panel were photographed with high-speed cameras to document crack propagation through the panel.

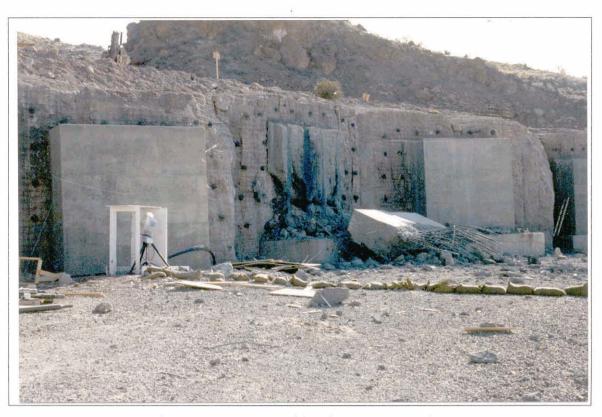
Figure 5. Test 1, resulting damage to Panel 1.

The explosive charges were to be initiated 8 msec apart. The first two holes initiated at the correct times (0 and 8 msec), while the second two holes initiated at the same time of the second hole (8 msec). The accelerometer data was collected and turned over to DSWA personnel. Figures 5 through 7 show the resulting damage to the panel.

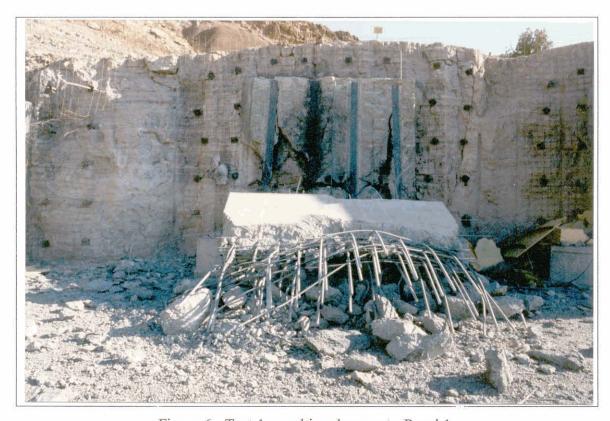
Figure 6. Test 1, resulting damage to Panel 1.

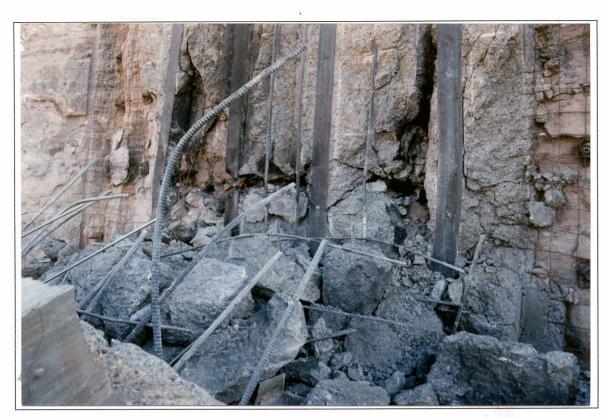
Figure 7. Test 1, resulting damage to Panel 1.

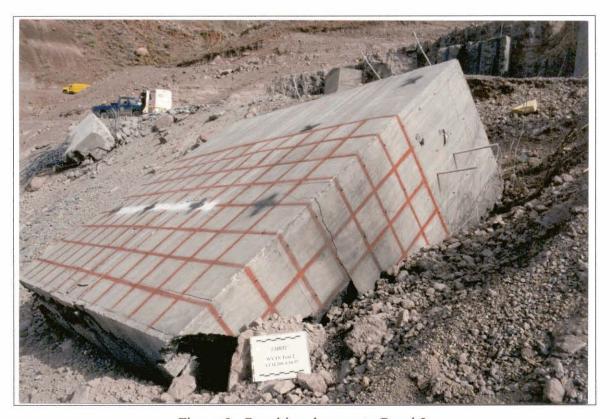
Figure 9. Resulting damage to Panel 2.

The sandstone wall behind the panel was drilled from the side with a single 4-inch hole parallel to the front concrete face (Figures 8 and B). The composition C4 explosive charge, 49.8 pounds with a loading density of 1.63 g/cc, was loaded into an acetate tube and stemmed with wood. Polyurethane foam was used on the side-wall and top of the panel to minimize the spall damage to the panel. The front face and sides of the panel were photographed with high-speed cameras to document crack propagation through the panel. Figures 9 through 11 show the resulting damage to the panel.

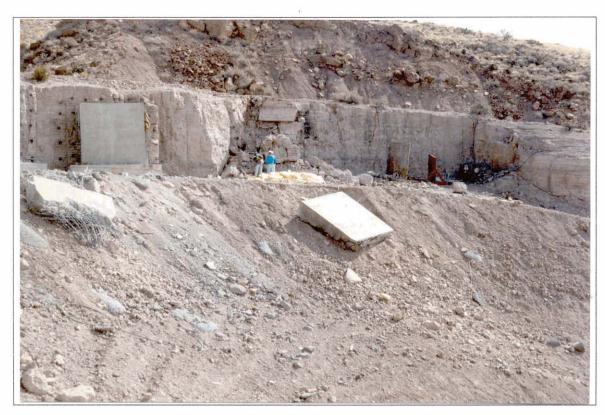
Figure 10. Resulting damage to Panel 2.

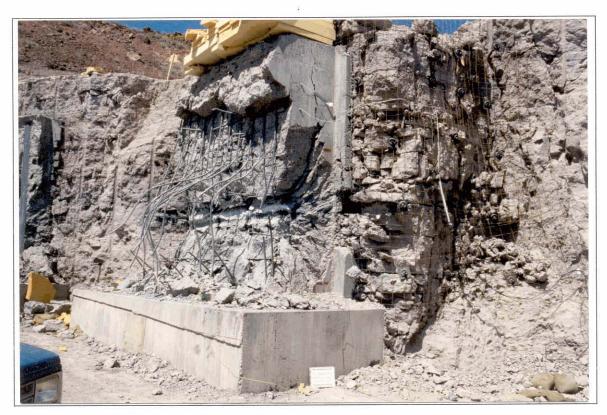
Figure 14. Test 3, Shot 1, resulting damage to Panel 3.

The panel was drilled from the side (parallel to the front face) with a single two-inch hole two feet back from the front face of the panel and 4 feet above the bottom of the panel (Figures 12 and C). The composition C4 explosive charge was 20.33 pounds with a loading density of 1.59 g/cc. The hole was stemmed with wood. Polyurethane foam was used on the side-wall and top to minimize the spall damage to the side and top of the panel. The front face and sides of the panel were photographed with high-speed cameras to document crack propagation through the panel. Figures 13 and 14 show the resulting damage to the panel.

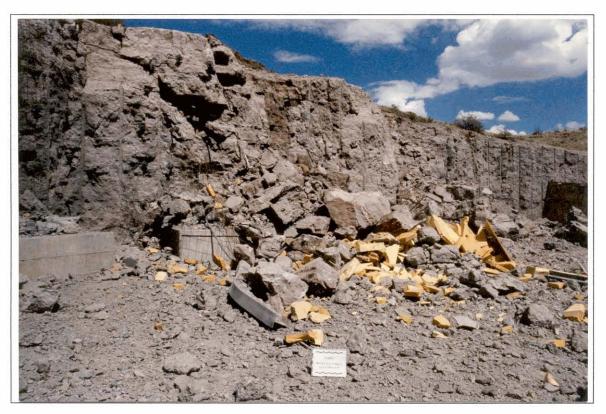
Figure 15. Test 3, Shot 2, resulting damage to Panel 3.

A second test was performed on the panel. A single 4-inch hole was drilled into the sandstone wall parallel to the hole drilled into the panel. The composition C4 explosive charge was 76.2 pounds with a loading density of 1.59 g/cc. The hole was stemmed with wood. The front face and sides of the panel were photographed with high-speed cameras to document crack propagation through the panel. Figures 15 and 16 show the resulting damage to the panel and sandstone wall.

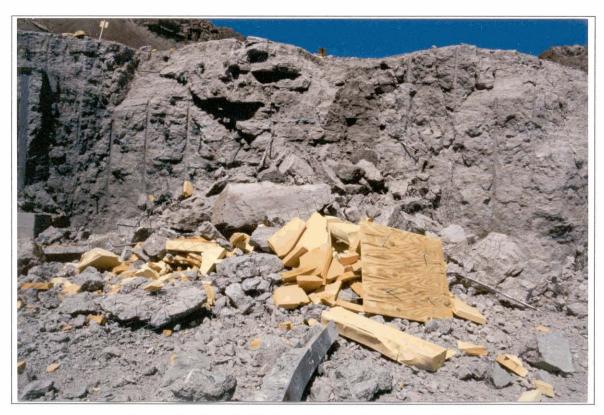
Figure 16. Test 3, Shot 2, resulting damage to Panel 3.

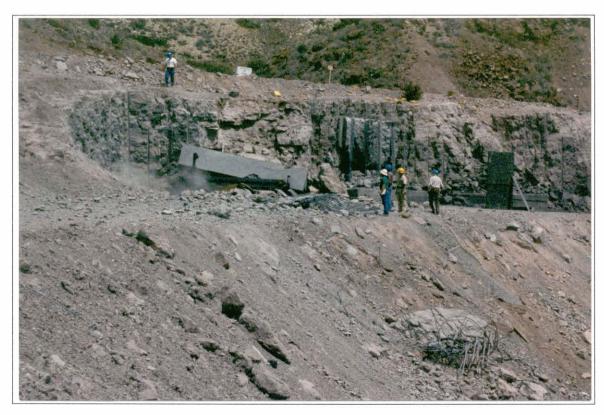
Figure 18. Test 4, resulting damage to Panel 4.

The panel was drilled with a 2-inch hole and the sandstone wall was drilled with a 4-inch hole in the same locations as the Panel No. 3 tests. The explosive charges were the same as those in the Panel No. 3 tests. The panel was pre-stressed to 70 psi using the load beam on the top of the panel (Figure 17). The charges were initiated with a 10-msec delay between the charge in the panel and the charge in the sandstone. The delay was obtained using 65.5 feet of shock tube on the sandstone charge. The holes were stemmed with wood. The front face and sides of the panel were photographed with high-speed cameras to document crack propagation through the panel. Figures 18 through 20 show the resulting damage to the panel.

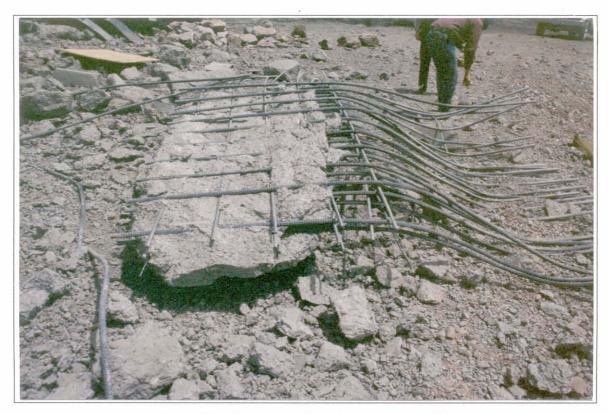
Figure 19. Test 4, resulting damage to Panel 4.

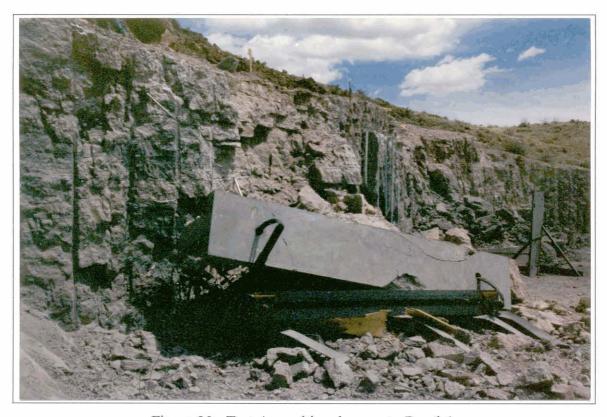
Figure 20. Test 4, resulting damage to Panel 4.
